**RE: Reports of Asbestos, Lead-Based Paint and "Universal Waste" Identification Surveys
Municipal Building and Police Department Building Feasibility Assessment
(A) Asbestos Identification Survey
(B) Lead-Based Paint Identification Survey
(C) PCB Mercury Liquid and Lamp Investigation ("Universal Waste")
808 & 818 Lacey Road
Lacey Township, Ocean County, New Jersey
T&M Project No. LACY-00097**

REPORT OF ASBESTOS IDENTIFICATION SURVEY

MUNICIPAL BUILDING AND POLICE DEPARTEMENT BUILDING FEASIBILITY ASSESSMENT

T&M Project No. LACY-00097

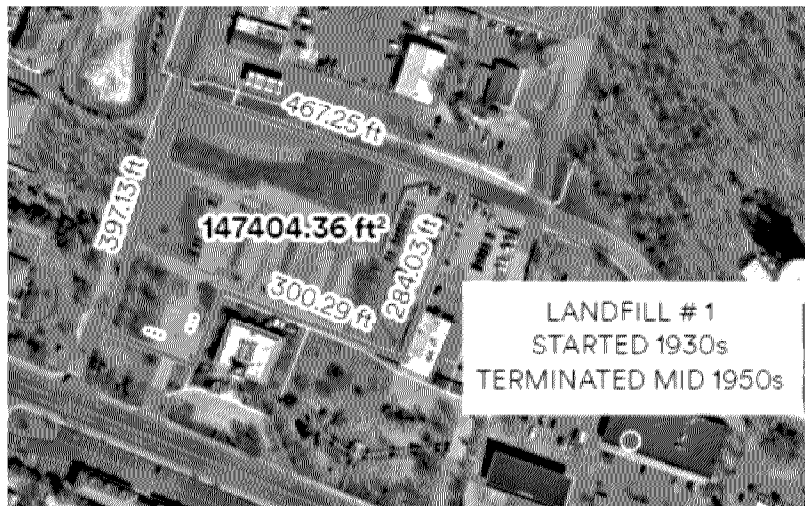
- a. **LANDFILL:** It is our understanding based on conversations with Township staff that the area north of the municipal building is an existing landfill. We were advised that the area was quarried for gravel (+/-5' below existing grade) and subsequently used as a landfill between the 1930's and mid-1950's. There was no specific information available on the NJDEP web site regarding this landfill. The eastern limit of the landfill was encountered during the construction of the Police building. The approximate limits of the initial landfill are shown below:

As you can see, the location of the proposed Municipal and Police additions will be over the landfill and will require submission to NJDEP Division of Solid Waste to confirm disturbing the current cap and securing a Landfill Disturbance Permit is feasible. For purposes of this assessment, we assume that the existing landfill material will be required to be replaced with structural fill to support the building.
